Challenging esthetics

38-year old female came to the clinic having lost tooth 22 due to an accident 3 years ago. No major bone resorption was seen in the area. A flipper was used as a temporary solution and the patient was referred to the clinic for implant treatment. After a thorough examination, an OsseoSpeed implant (Astra Tech Implant System) in combination with an Atlantis Abutment in zirconia was selected in order to achieve an excellent esthetic result.

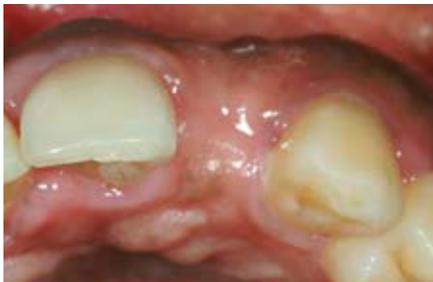
1. Clinical examination showed hardly no horizontal or vertical bone resorption at position 22.

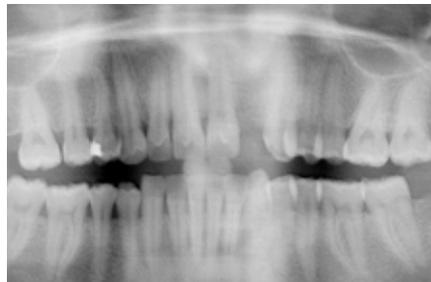
2. The panoramic radiograph confirmed the clinical examination.

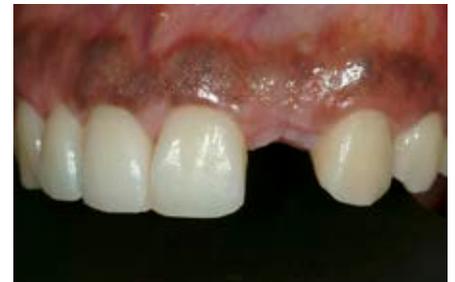
3. Intra oral examination showed optimal soft tissue condition and papillae.

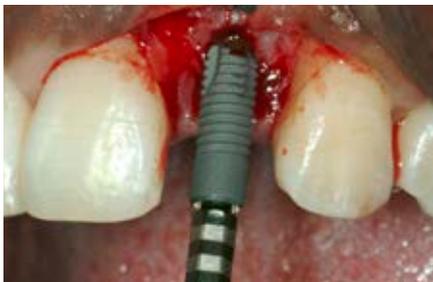
4. Implant installation of an OsseoSpeed 3.5, 11 mm implant (Astra Tech Implant System).

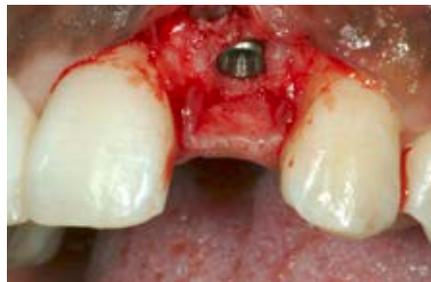
5. A sulcus incision was made in order to preserve the papillae. The implant neck was placed 2-3 mm below the cervical area of the opposing lateral incisor (12).

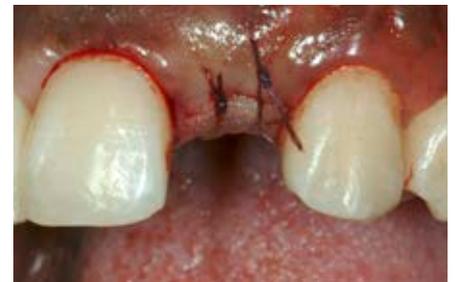
6. The implant was placed in a two-stage procedure. Sutures were removed after 7-10 days.

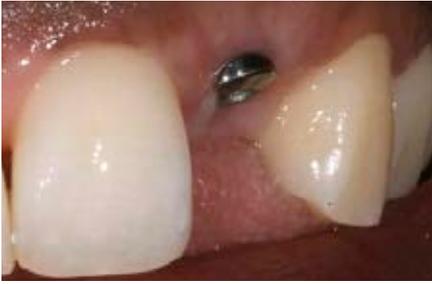
7. 8 weeks after implant surgery a 4 mm crestal incision was made to remove the cover screw and a healing abutment was installed.

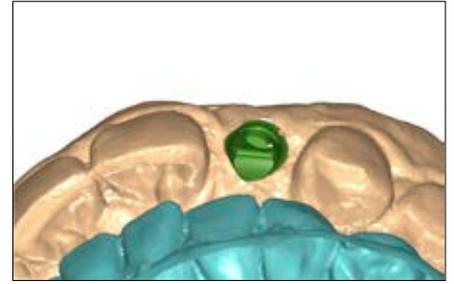
9. The Atlantis patient-specific abutment was individually designed from the final tooth shape, using the Virtual Atlantis Design (VAD) software.

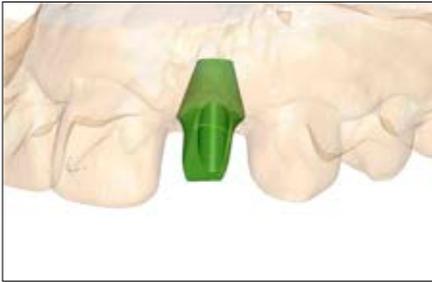
10. The emergence width option “full anatomical dimensions” was selected to provide the best emergence profile possible. Images were sent to the dental technician for design approval.

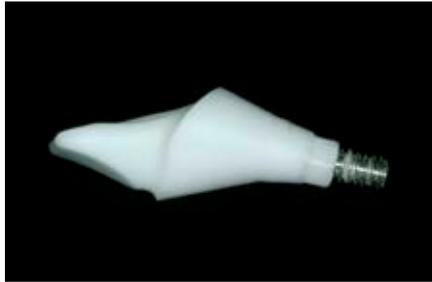
11. The patient-specific Atlantis Abutment in zirconia ready for clinical placement. Due to the optimal design based on the crown shape there is no need for adjustments.

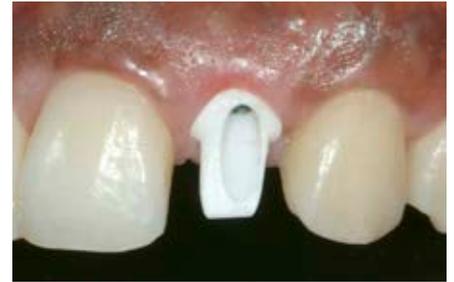
12. The Atlantis Abutment in place, tightened with finger light force.

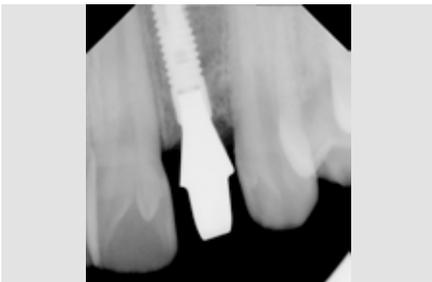
13. A radiograph was taken to ensure proper seating.

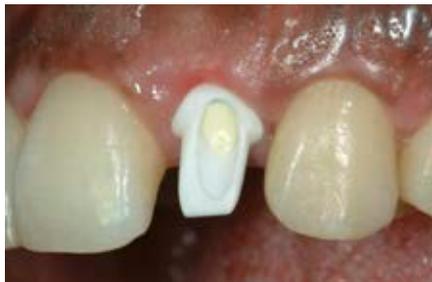
14. Final torque at 20 Ncm. After a few minutes the abutment was tightened again to verify proper seating. The screw hole was covered.

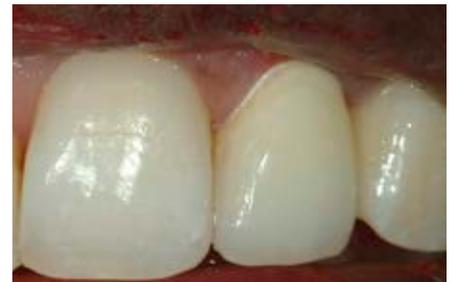
15. A ceramic crown was cemented directly after installation of the Atlantis Abutment.

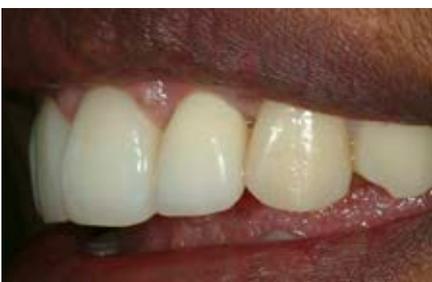
16. Buccal view of the restored tooth, 4 weeks after abutment and crown placement.

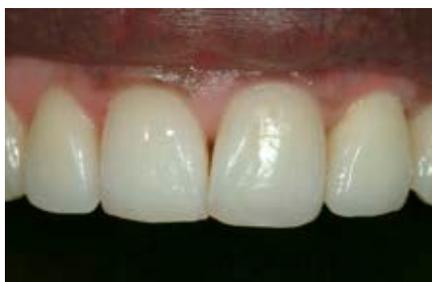
17. Facial view of final restoration.

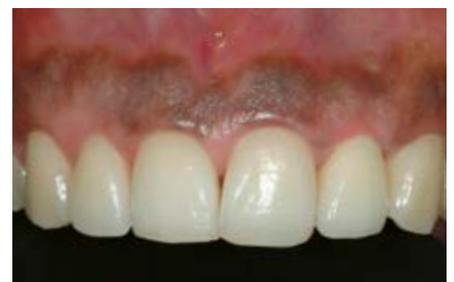
18. Final excellent esthetic result with a perfectly healed soft tissue.
